Safety Note

2018.10.09 - **PowerSeat** harness

Dudek Paragliders www.dudek.eu

PowerSeat harnesses from H-03655 serial number

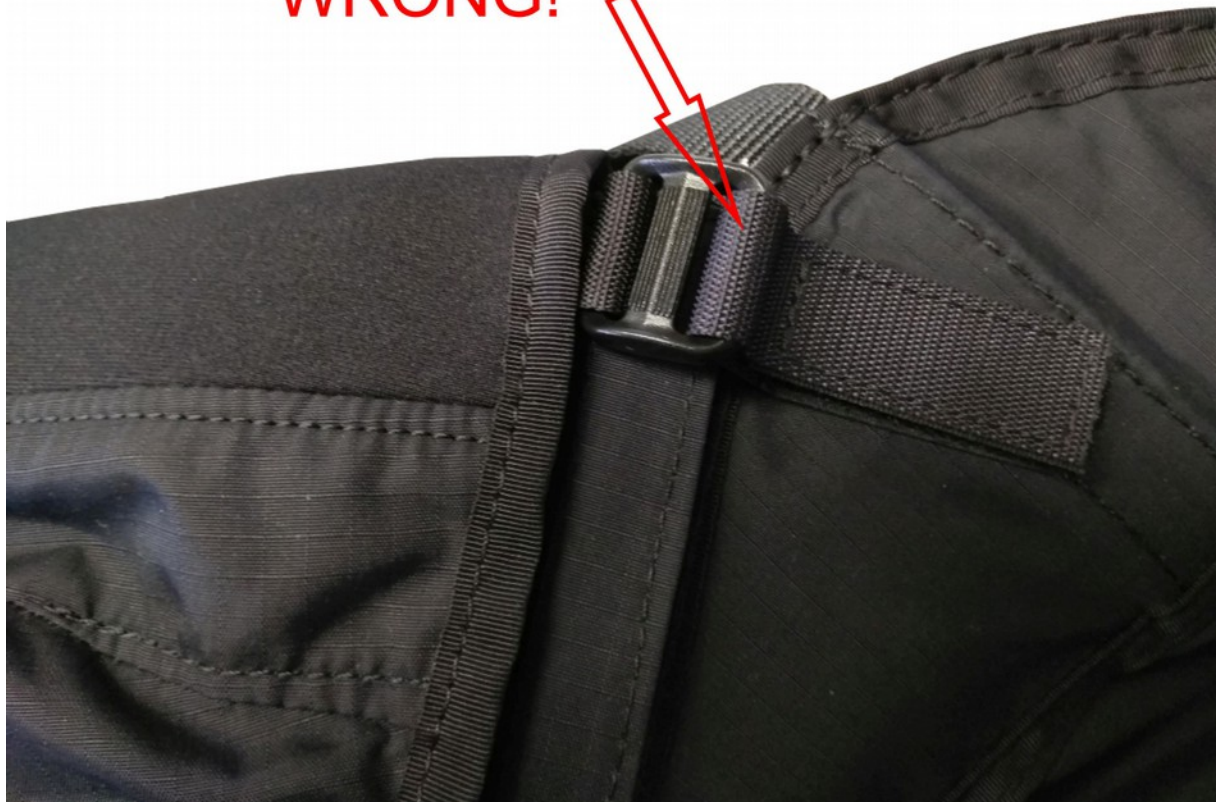
WRONG!

It was noted that some pilots put the velcroed strap through the buckle in a wrong way, as a result negating any protection for the zip. This can lead to detaching the side container or pouch.

Below you can see an example of faulty connection:

Check if the strap is fixed properly. Pictures below represent the right way of attaching the side container and side pouch to the Powerseat harness. The strap must be led over the center of the buckle. The strap fixed in this way protects the zip against damage that could possibly result in detaching them from the harness.
