Notice about Warp 3

These instructions mainly apply to the Warp 3 wings with serial numbers of: P-xxxxx1, and P-xxxxx2.

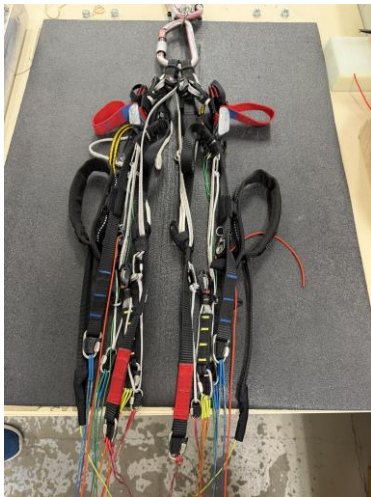
1. Attach the risers to a stable point or ask another person to hold them.
2. Select the main lines of row C and C' (CP1, CP2, CP3).

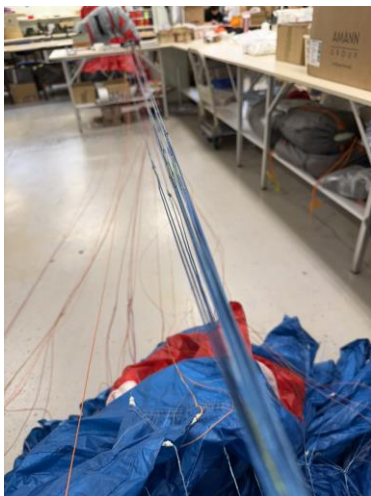
3. Move to the wing canopy.

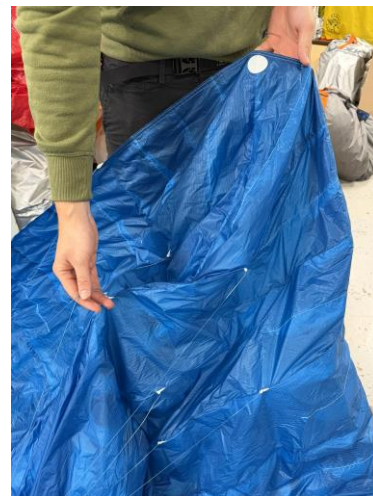
4. Starting from the center, grab the first pair of corresponding lines in row C (left and right side).

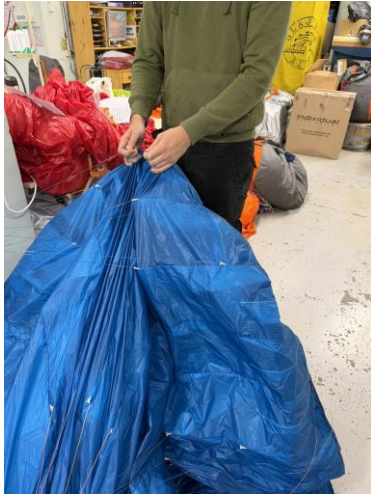
5. Pull the lines symmetrically with a force of about 15–20 kg.

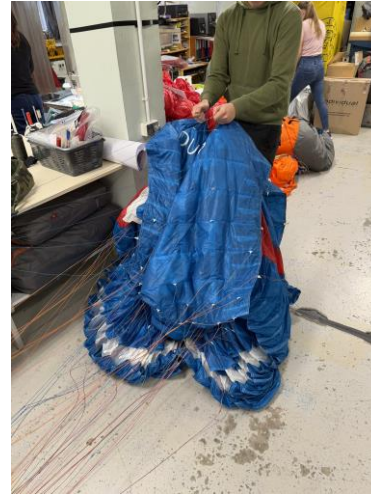
6. Repeat for all lines in row C, then do the same for row D.

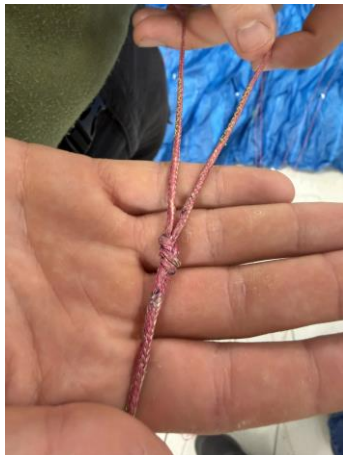
9. Loosen the first connection of the main line.

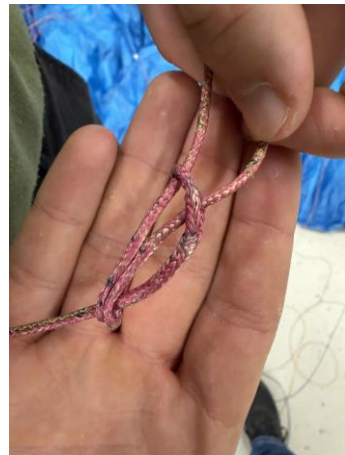
10. Make the loop as shown in the video linked below.

11. If needed add another loop as shown on the video linked below.

Make sure the loops are straight, without twists, and tightened. After completing all procedures, visually inspect the wing on the ground before the first flight. If you are not confident, it is best to take the wing to a professional service.
